Manhole Inspection Summary

Manhole # S35S__035MH

Insp Date: **2/13/08 12:56 PM**

Location Address: **unnamed alley**

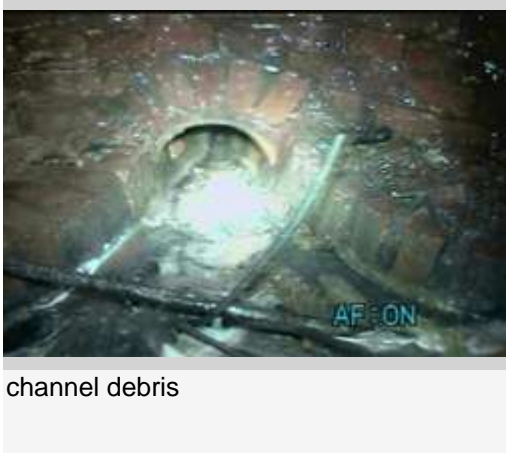
Defect 1

Condition: ☐ Sound ☐ Cracked ☐ Root Intrusion ☐ Deteriorated ☐ Leaks ☒ **Debris**

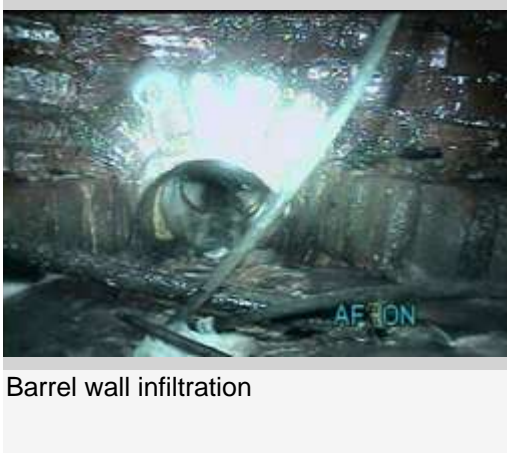
Defect

Barrel wall infiltration

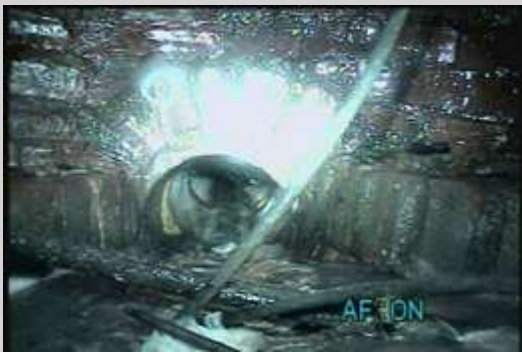
12 O'Clock Outflow

8 in. Circular Gravity Sewer
Pipe Out @ 12 O'Clock

Invert Depth: **12.00** (ft.) Flow Characteristics: **Slow**

Infiltration: **None**

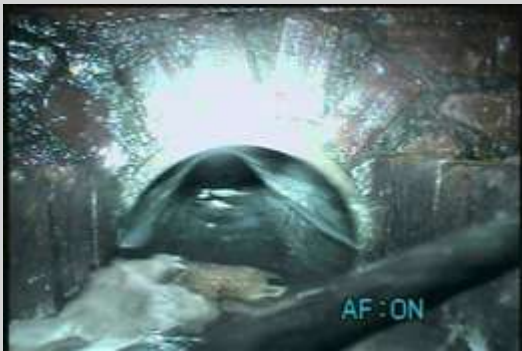
3 O'Clock Inflow

8 in. Circular Gravity Sewer
Pipe In @ 3 O'Clock

Invert Depth: **11.80** (ft.) Flow Characteristics: **Slow**

Infiltration: **None**

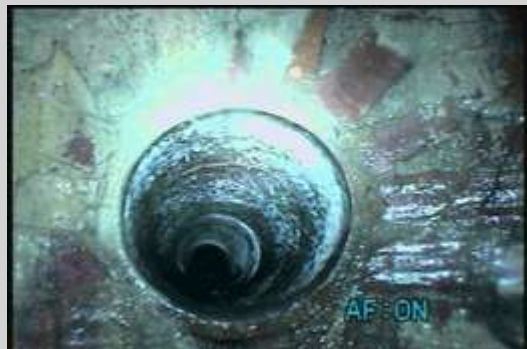
9 O'Clock Inflow

Pipe In @ 9 O'Clock

Invert Depth: **6.50** (ft.) Flow Characteristics: **Slow**

Infiltration: **None** Pipe Seal Cond: **Unknown**

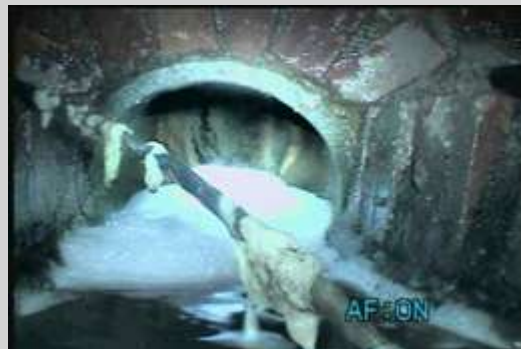
Drop In @ 9 O'Clock

Drop: **Inside** **Direct**

Inv Depth: **11.90** (ft.)

Drop Condition: **Open**
